# Reconnecting the Rockies:BC

## 2020-2024 Progress Report

3 February 2025

**Prepared for:** British Columbia Ministry of Transportation and Transit, and the Ministry of Water Land and Resource Stewardship

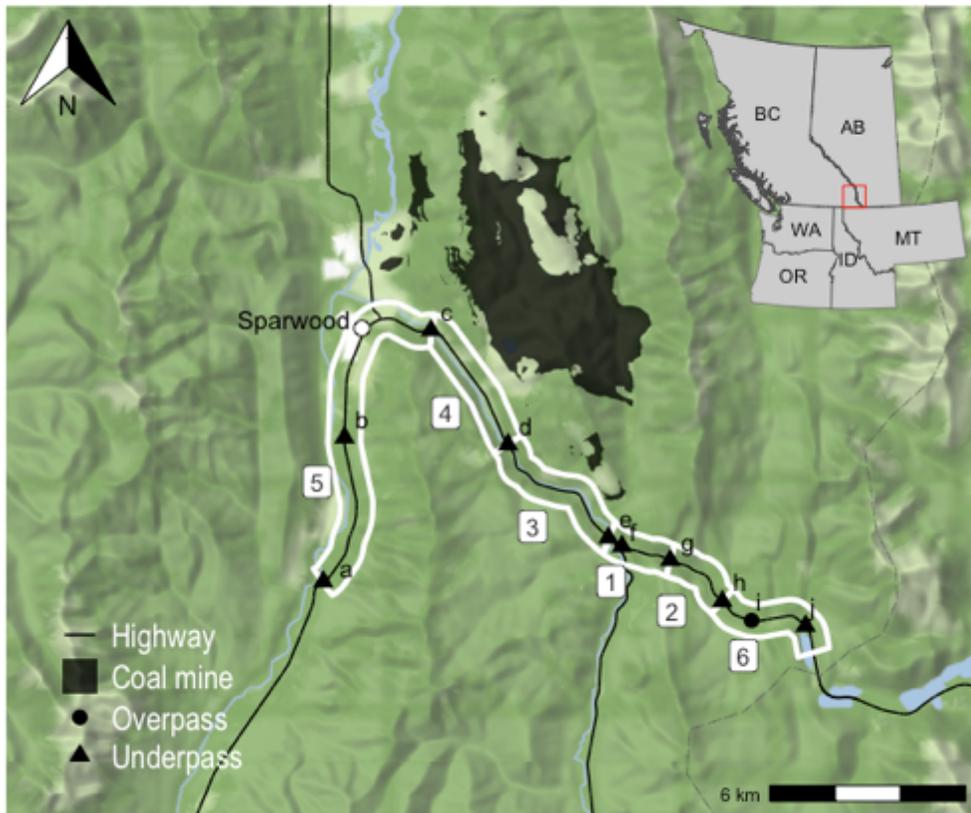
*Figure 1: Project location along Highway 3 in southeast British Columbia, Canada. The project is proceeding in 6 phases (depicted as number in white squares), which correspond to the following years: 1=2022 (complete), 2=2024 (complete), 3-6=2025-2027. Crossing structures are as follows: a) Olsen Overhead, b) Sparwood West, c) Michel (complete), d) Old Town (complete), e) Loop (complete), f) Loop Overhead (complete), g) Carbon (complete), h) Alexander (complete), i) Alexander-Michel, and j) Crowsnest.*

The RTR:BC project area is located along Highway 3 in British Columbia, with an eastern boundary near the Alberta border, and a western boundary between Sparwood and Hosmer (Figure 1). Within the 27 km project area there are ten proposed wildlife crossing structures. Of these ten proposed structures, one is a large overpass (~50 m wide) in the Alexander-Michel corridor, two are purpose-built wildlife underpasses, and seven are existing open-span bridges over creeks (5) or railway tracks (2) that will be retrofitted to facilitate wildlife passage. At each structure, retrofitting often means manually creating trails to facilitate movement underneath, therefore acting as an underpass for wildlife to safely cross the highway. Wildlife exclusion fencing will be erected along most of the 27 km project area (except within Sparwood) to exclude wildlife from the highway and direct them towards the crossing structures.

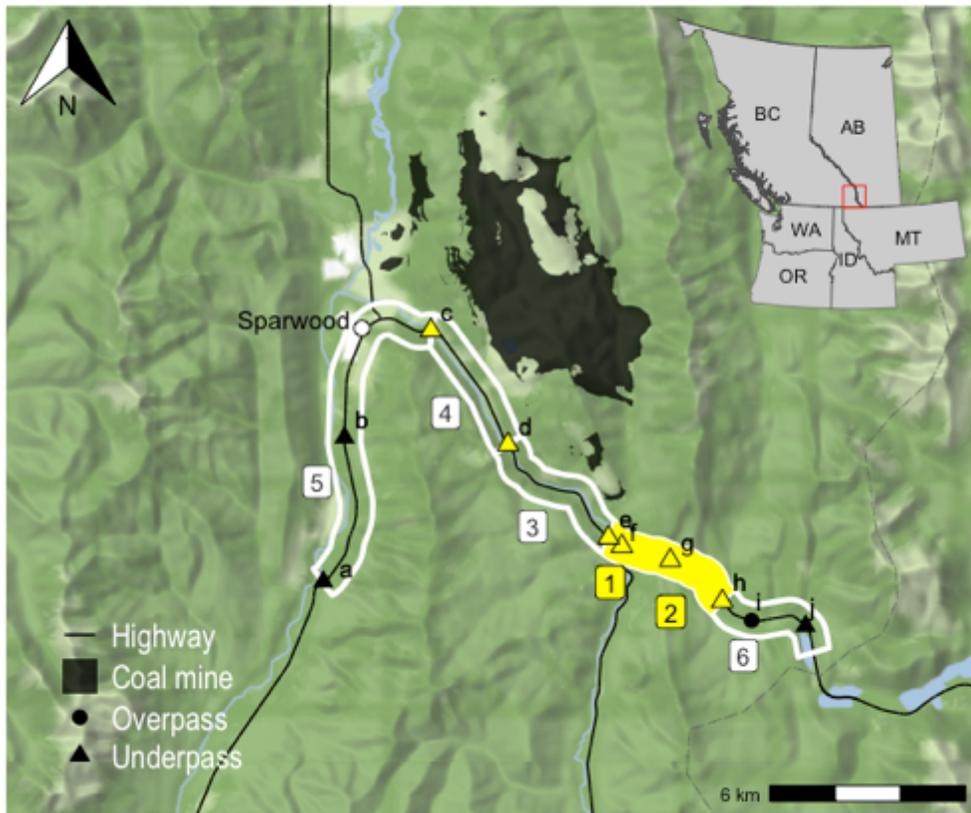
*Figure 2: Progress on fencing and crossing structures to date. Completed structures and sections of fence highlighted in yellow. Phase 1 structures are Loop Bridge, Loop CP overhead, and Carbon Bridge, from left to right. Alexander bridge was retrofitted in 2022 to prepare for Phase 2 fencing.*

To date we have completed Phases 1 and 2, and are on track to complete Phase 3 for 2025. We have constructed 8.4 km of fencing (4.2 highway km's) in 2020-2024 and retrofitted 6 underpasses.

In 2021, we retrofitted Loop Bridge and Carbon Creek Bridge. These sites were selected as they offered an opportunity to improve wildlife movement at minimal cost. We also completed geotechnical surveys at the proposed overpass site. In 2022, we retrofitted Alexander Creek Bridge. We erected wildlife exclusion fence on both sides of the highway between Loop and Carbon Bridges in 2022 to connect the two structures retrofitted in 2021. Work on Alexander Bridge completed in 2022 prepared for phase 2 fencing between Carbon and Alexander which was completed in fall 2024. In 2024 we also retrofitted Old Town and Michel Creek bridges with walking paths across the rip rap.

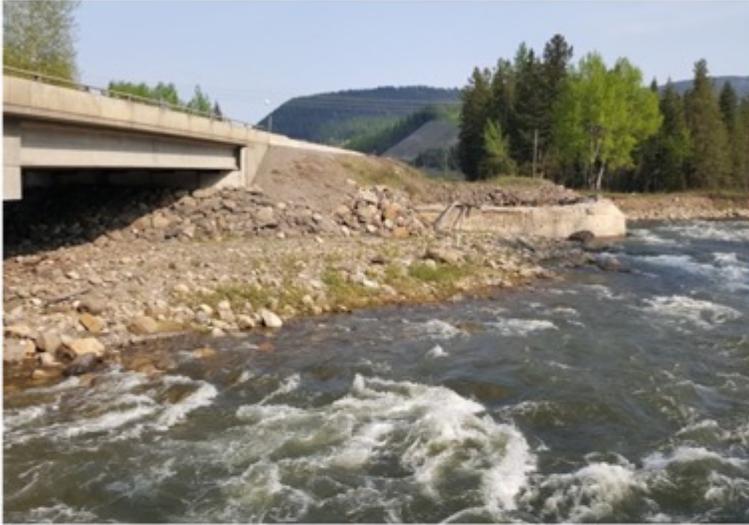
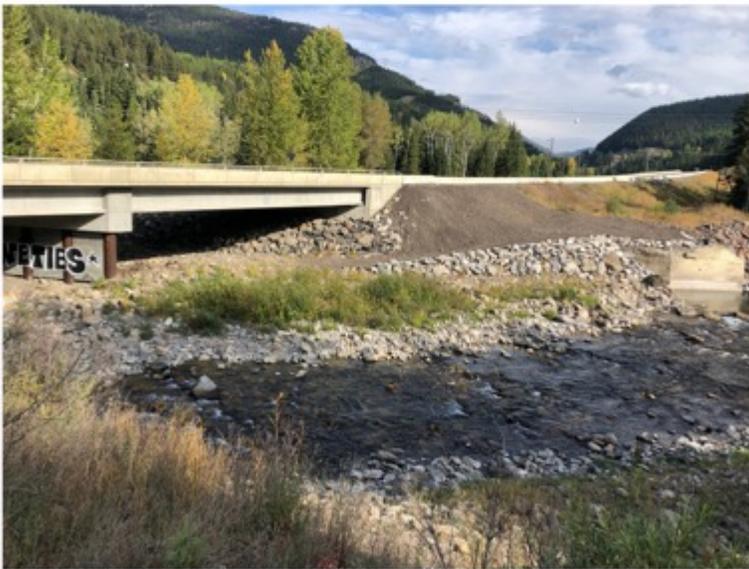
## Loop Bridge

*Image 2. Example of an underpass retrofit at Loop Bridge. Here a large open span bridge had the potential to provide an effective underpass below the highway, but rip rap and an old abutment blocked animals from easily entering the river edge. We removed a portion of this abutment and created a 10 ft wide path down to the underpass that makes the structure more enticing and safer for wildlife.*

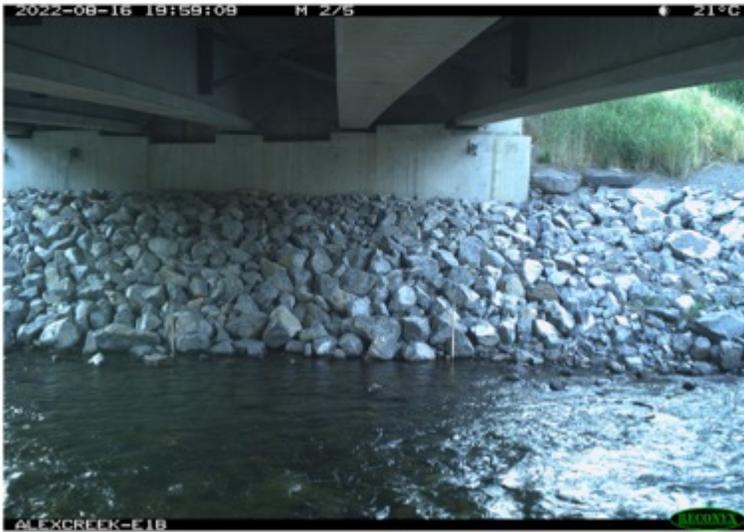
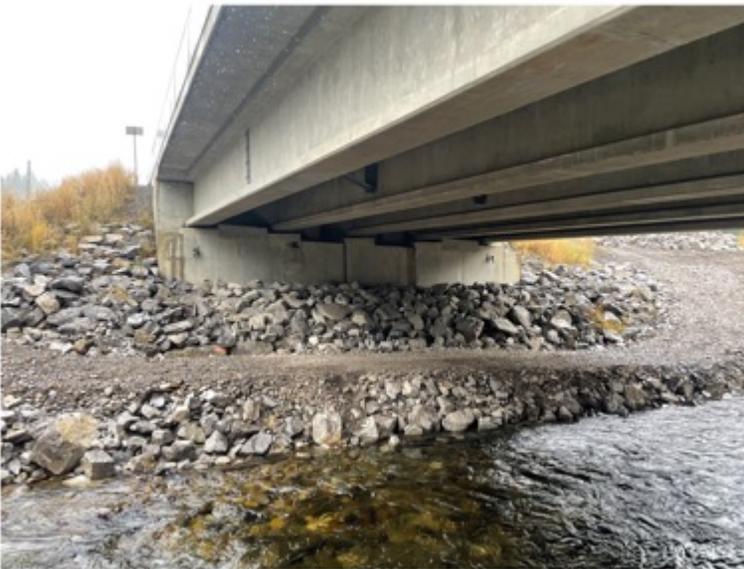
## Alexander Bridge

*Image 3. Example of an underpass retrofit at Alexander Bridge. Here a large open span bridge is in an ideal crossing location, but due to the rip rap right up to the creek there was limited opportunity for wildlife to cross under the bridge unless they went in the creek. While the creek is passable for some of the year, its is challenging to cross in the spring during high water, and during the winter when the creek is partially frozen. We engineered a solution that allowed a 1.5 m wildlife path through the rip rap while still protecting the infrastructure. In some high water*

years the smaller gravel from this path will be washed away but it can be replaced by hand when needed.

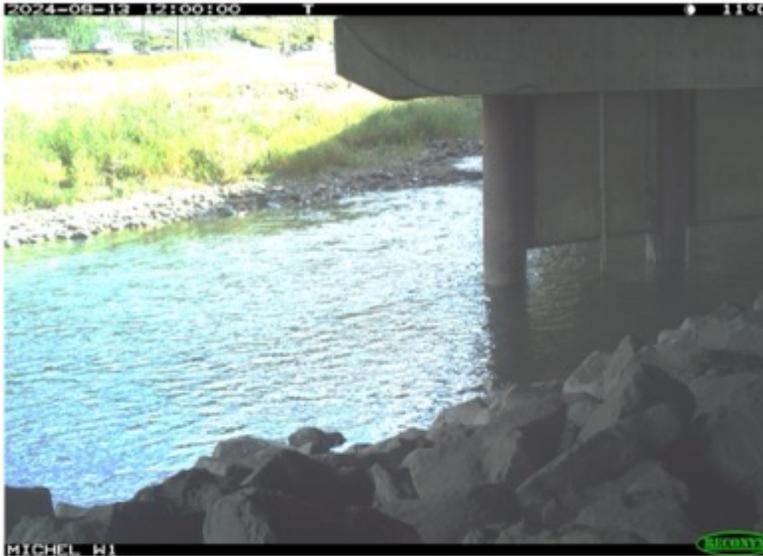
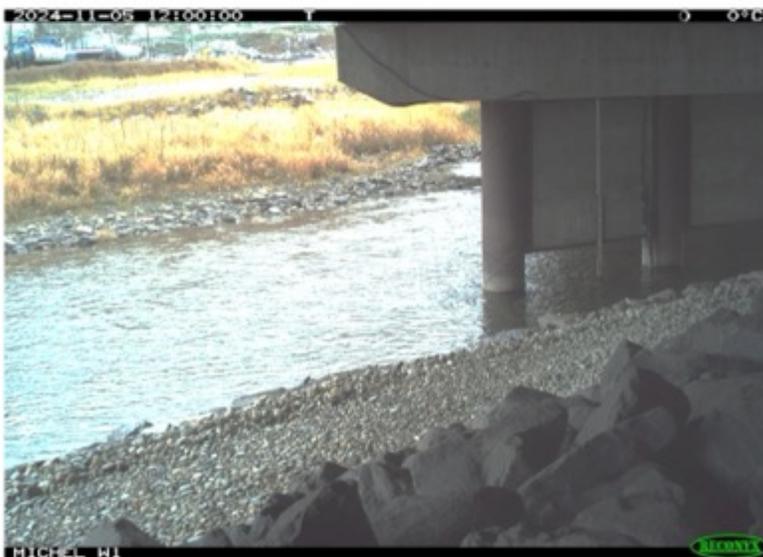
## Michel Bridge

Image 4. Example of an underpass retrofit at Michel Mouth Bridge. A similar approach to Alexander Creek was used here, where a 1.5 m wide path was created through the large rip rap and filled with pea gravel to create a surface more ammenable to wildlife use on both sides of the bridge.

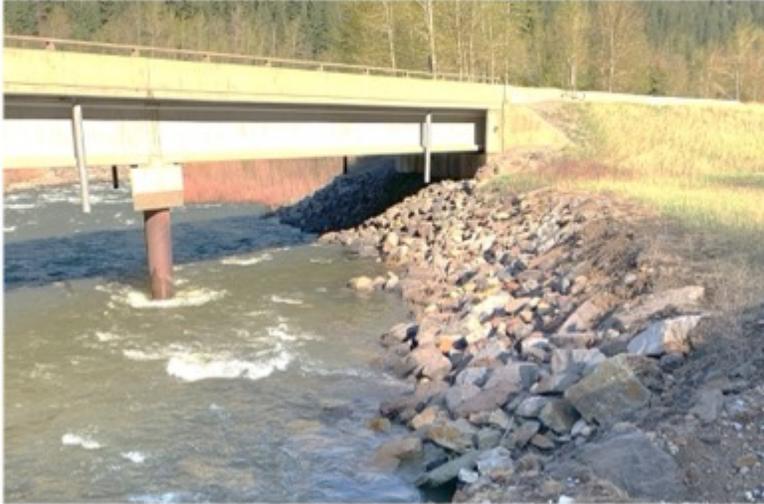
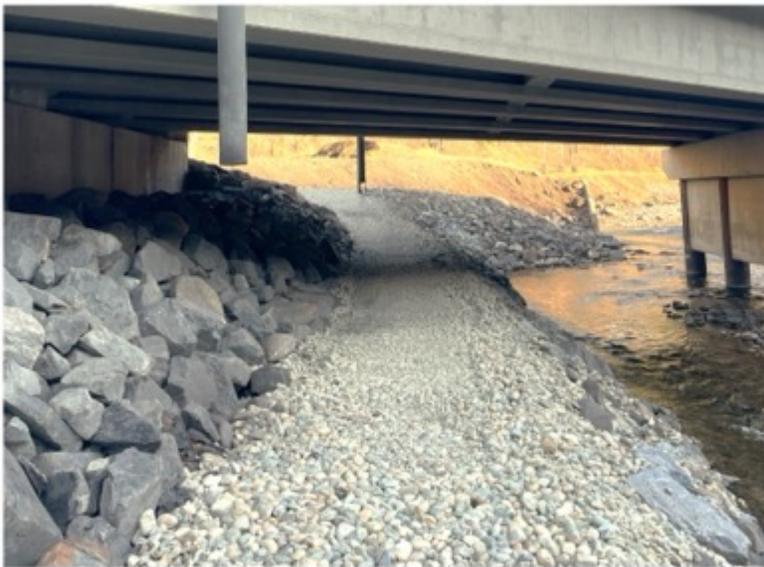
## Old Town Bridge

*Image 5. Example of an underpass retrofit at Old Town. A similar approach to Alexander Creek was used on the NW side of the bridge, where a 1.5 m wide path was created through the large rip rap and filled with pea gravel to create a surface more amenable to wildlife. The SE side of the bridge was already very open and serving as an underpass with no work needed. use.*

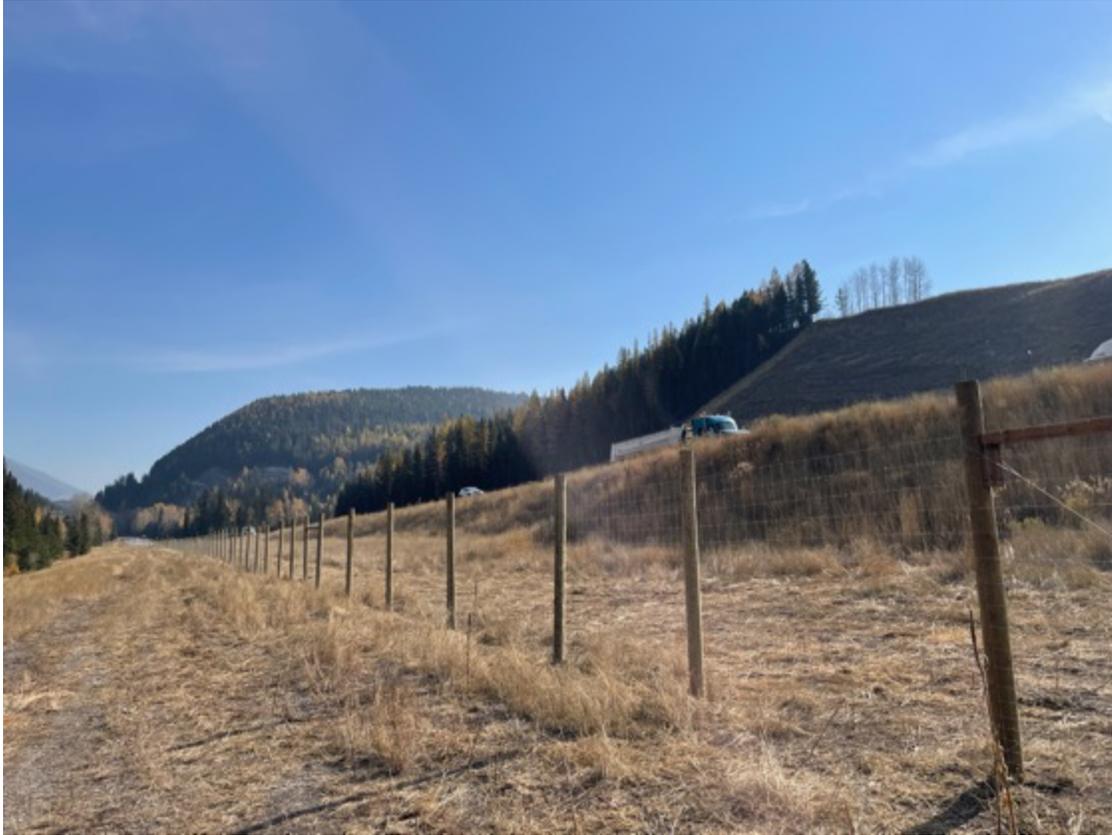
*Image 6. Phase one wildlife exclusion fencing between Loop Bridge and Carbon Bridge.*

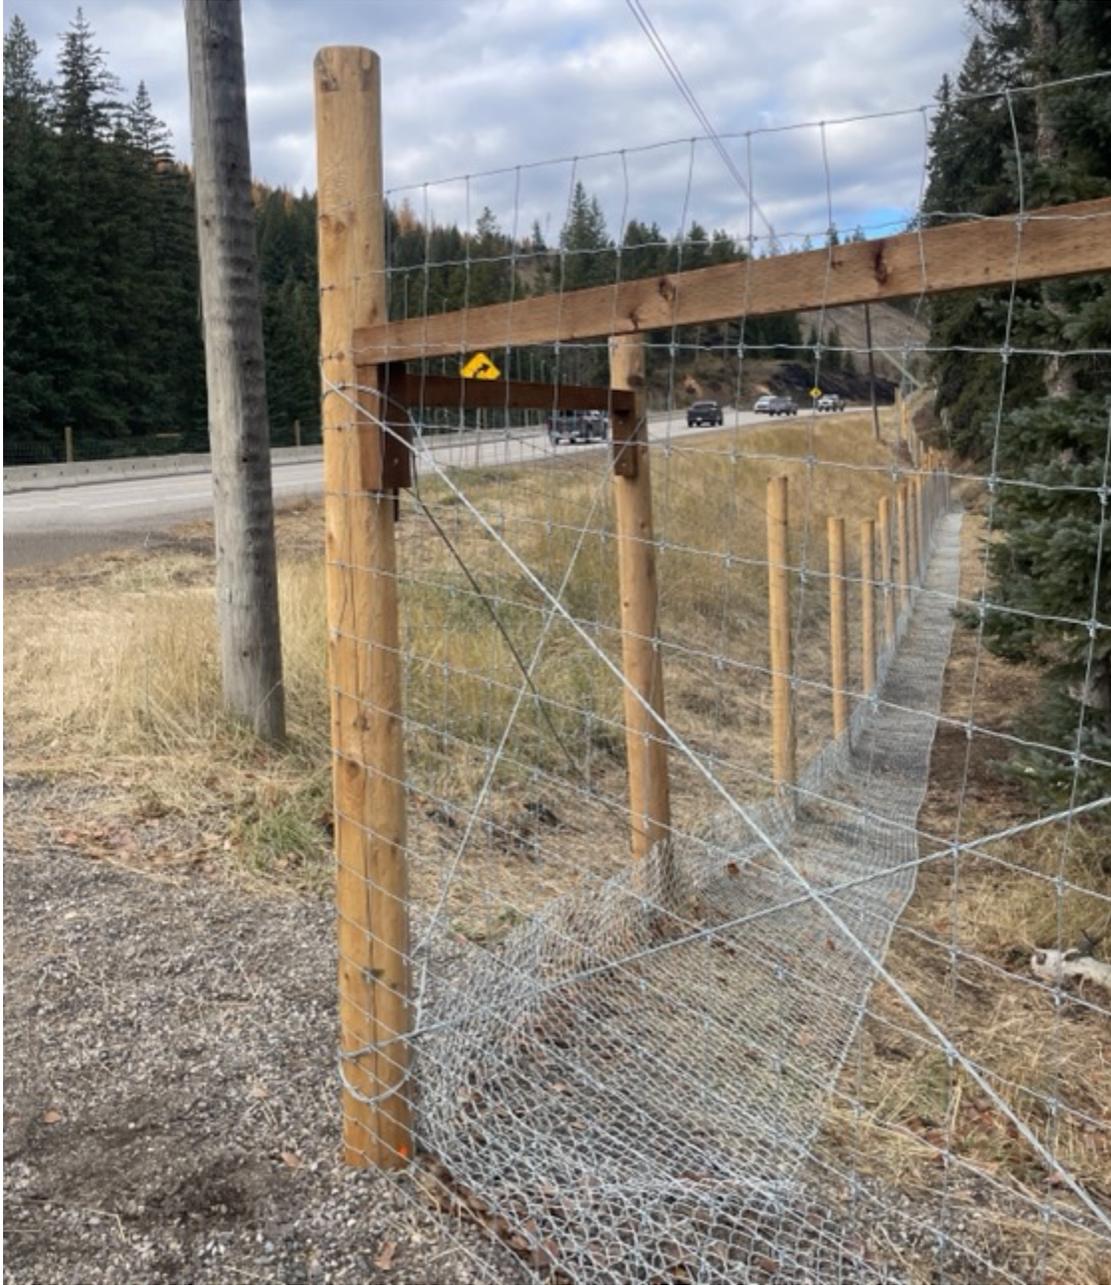
*Image 7. Phase two wildlife exclusion fencing between Carbon Bridge and Alexander Bridge. Chain link skirting to reduce animals digging under the fence shown at the bottom.*

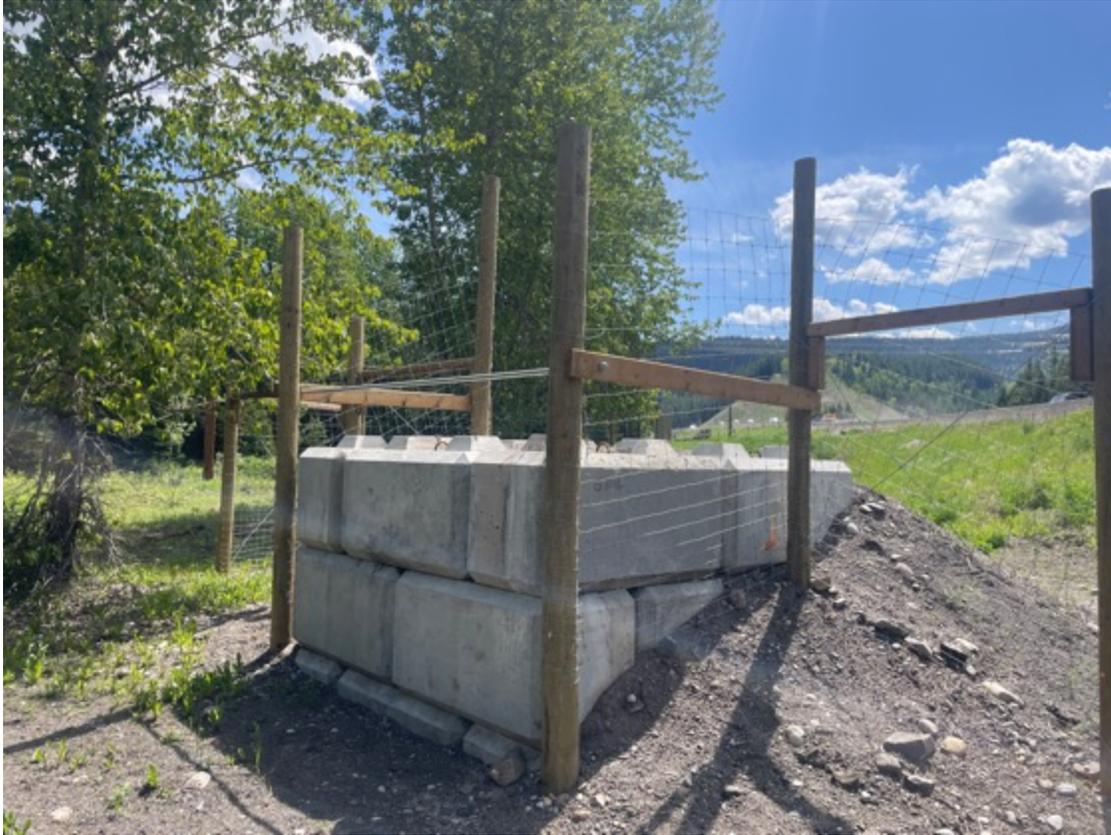
*Image 8. A jumpout along the Phase one fence. The jumpout was designed based on extensive testing from Arizona using elk, bighorn sheep, and deer (Gagnon et al. 2020). This design is simple and allows animals to safely exit the highway if needed, while precluding animals from jumping into the highway right of way in reverse. Where sheep are a concern the grooves between the blocks should be filled. The horizontal bar at 45 cm above the exit ramp reduces animals jumping back into the right of way.*

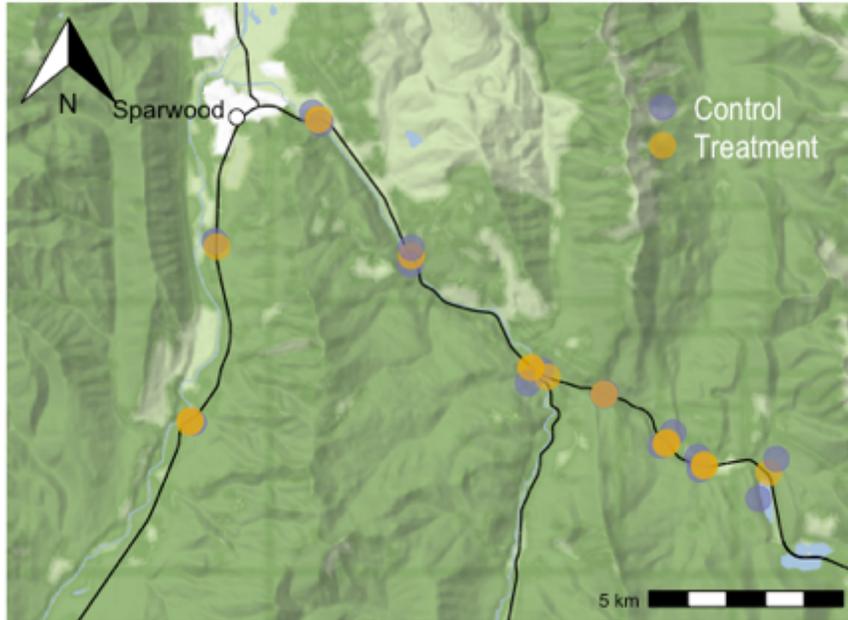
*Figure 3: Cameras monitoring crossing structures (Treatment) and adjacent wildlife trails within 500 m of highway (Control).*

At existing structures, two cameras have been deployed under the structure on each side to capture the animals that cross before bridge retrofitting and fencing (i.e. the "treatment"). Monitoring then continues after treatment to assess changes. Paired control cameras (2 per site) are placed up to 1 km from the road crossing in a representative habitat on a wildlife trail to capture which animals are present in the area surrounding the crossing that we would expect to also be represented in similar frequency at the crossing structure. On sites that do not have an existing structure, control cameras are deployed in standard fashion and the treatment cameras are deployed on an existing wildlife trail near the highway (within 100 m). When the crossing structure is installed, a camera will be mounted to capture which animals use the crossing structure.

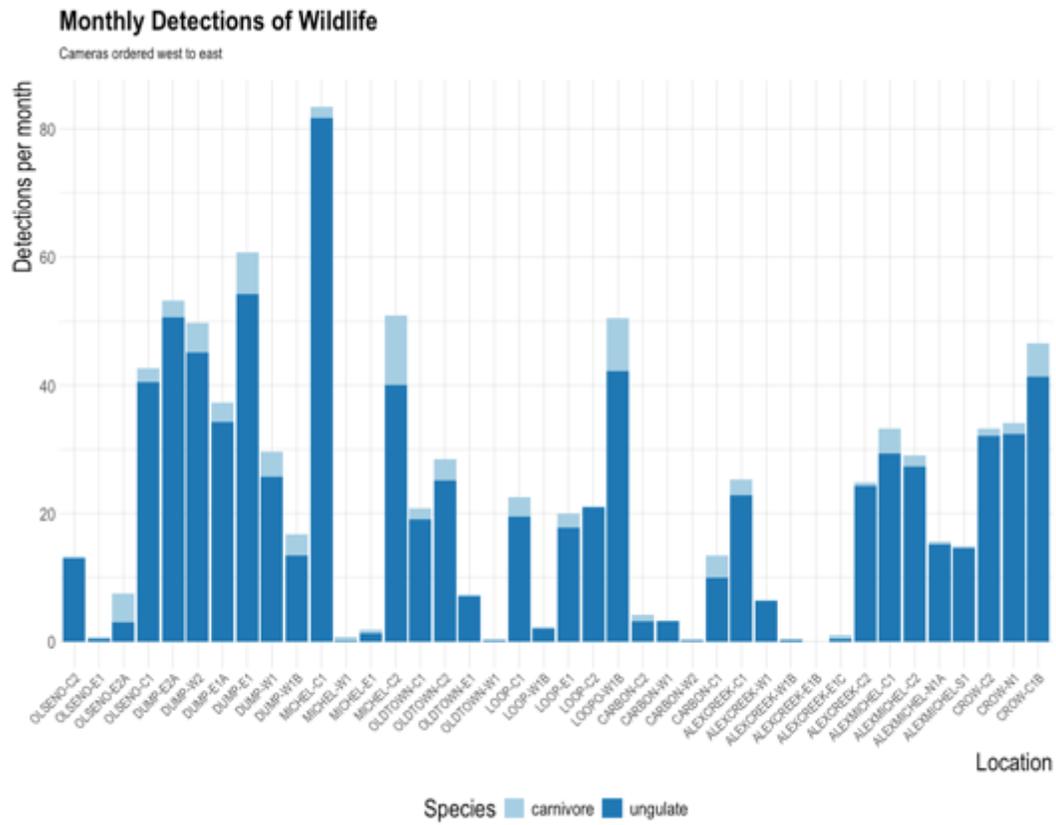
Figure 6: Average monthly detection rate for each camera.

Loop Bridge, and Sparwood West (Figure 6 & Figure 9). Human use of the structures varied and needs to be monitored closely, and perhaps reduced, once fencing is in place 7).

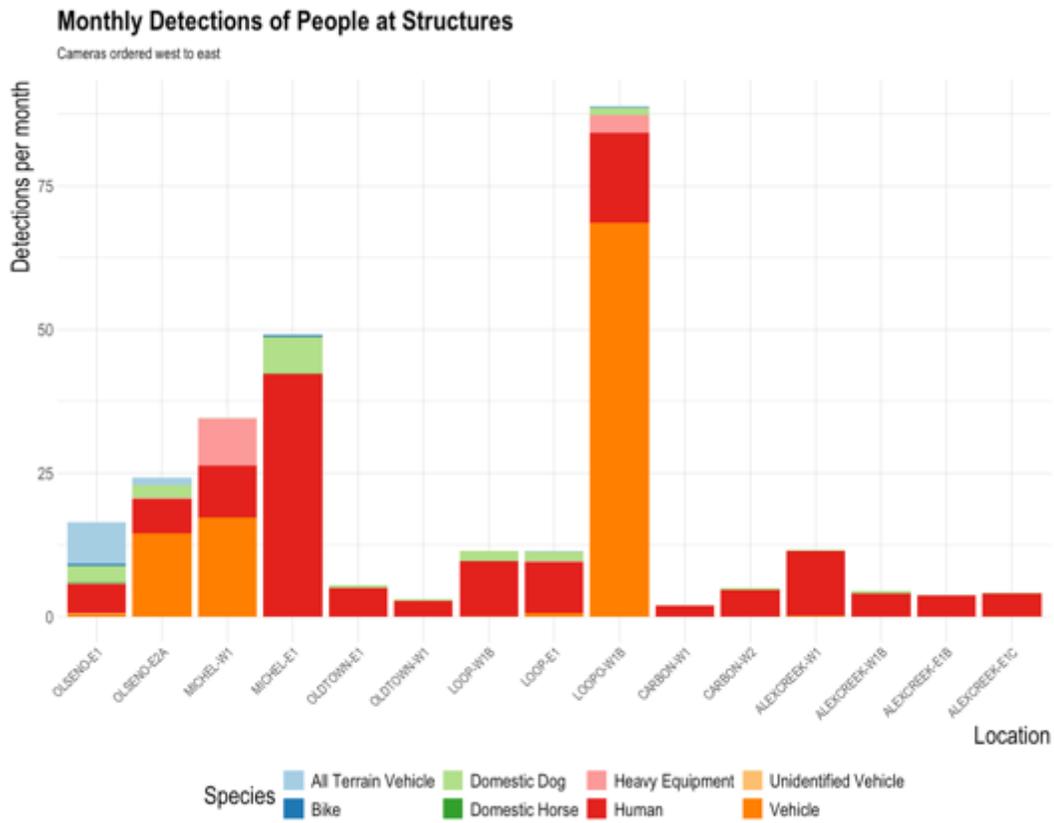
Figure 7: Average monthly detection rate for people at each camera. Trains removed to increase comparison between structures. Loop overhead and Olsen overhead each see 150-500 trains per month

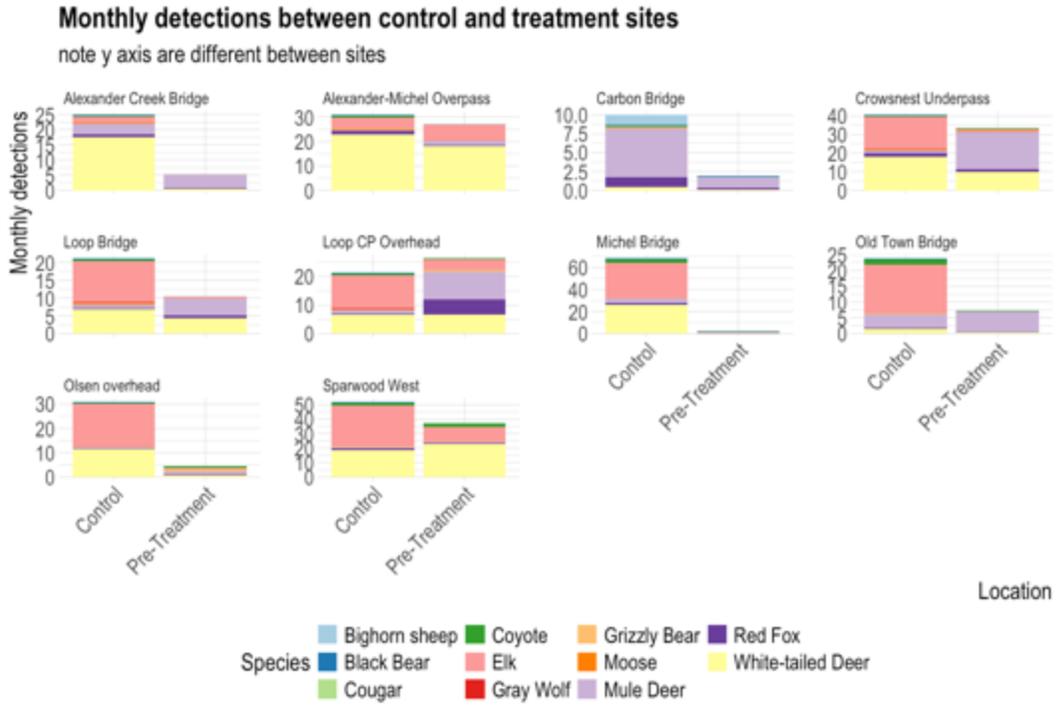
Figure 9: Detection rate comparison between treatment and control cameras.

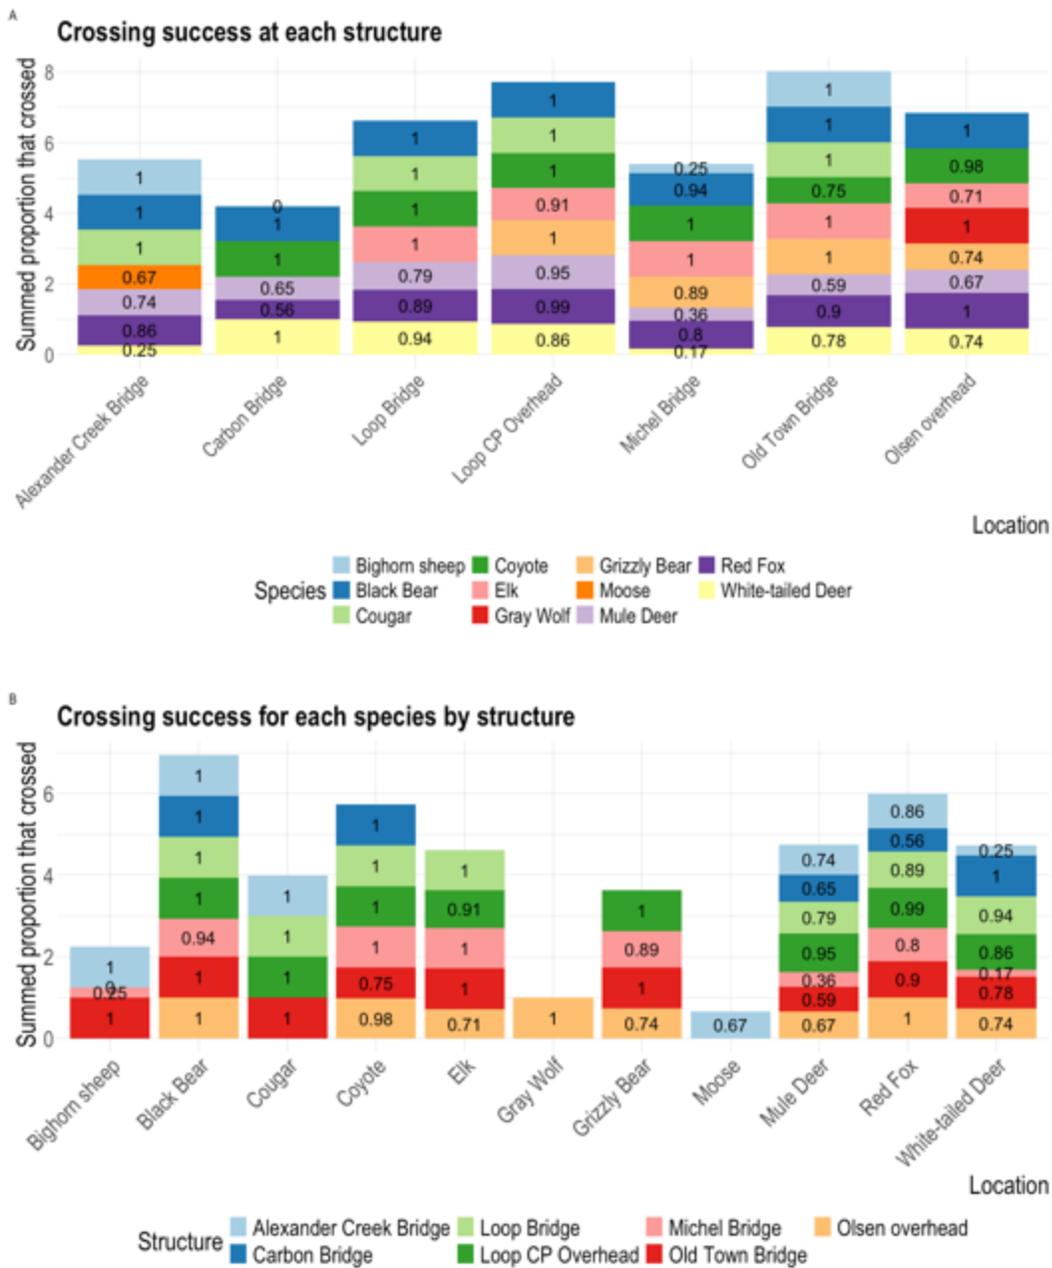
Figure 10: Proportion of successful crossings observed (crossing success) at each site (A) and by species (B). A value of 1 means all individuals of that species who entered the structure were observed crossing through the camera field of view. A value of 0.5 would mean that only half the animals successfully crossed, while the other half turned back the way they came and did not cross.

We monitored crossing success as the proportion of wildlife that entered each structure and crossed through to the other side (Figure 10). Crossing rates were highest for Loop CP Overhead and Loop Bridge, and lowest for Alexander Creek Bridge and Michel Creek Bridge. Bighorn sheep had the lowest rates of successful crossings, while black and grizzly bear, and elk, had the

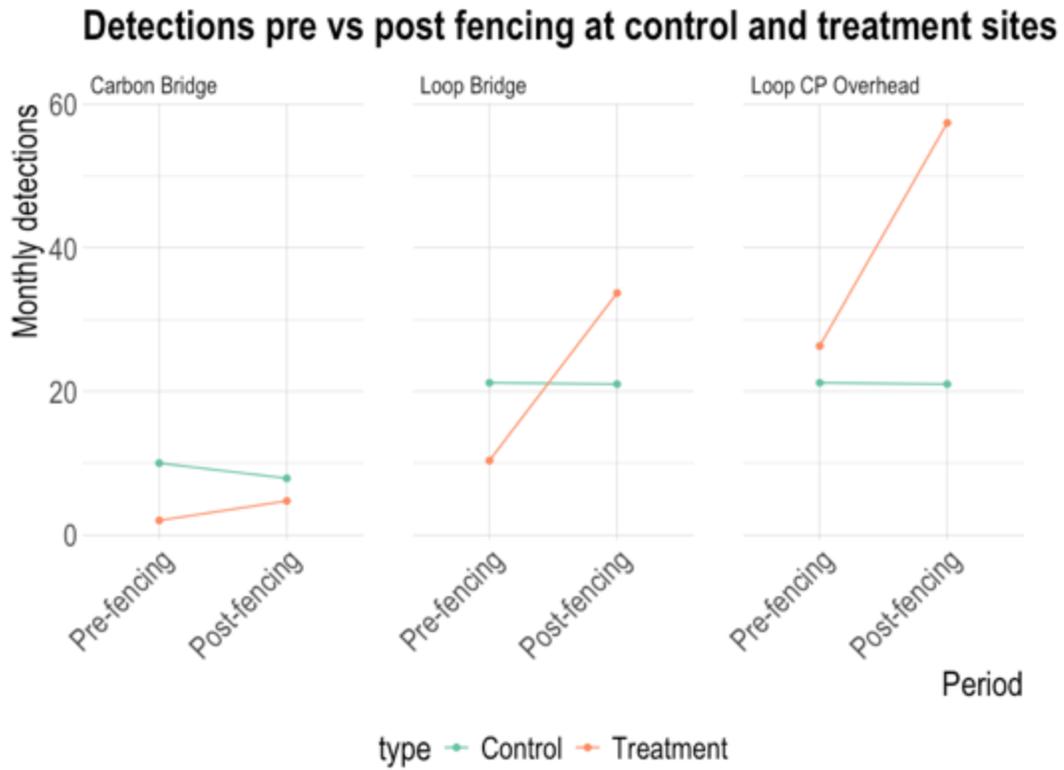
*Figure 11: Before-after-control-impact assessment of detection rate before and after fencing at treatment cameras under structures and control cameras adjacent to structure in forest*

We assessed monthly detection rates for structures within the Phase 1 fencing completed fall 2022. The before-after-control-impact design provided strong evidence that animals were dramatically increasing their use of the Carbon, Loop and Loop CP overhead structures following fencing (Figure 11). Carbon bridge, which is a small structure with limited potential as a crossing site due to low overhead dimensions, but even this structure saw a more than doubling in crossing rates post fencing. Compared to pre-fencing levels, wildlife detection rates increased post-fencing at the Carbon, Loop, and Loop CP overhead structures by 134%, 225% and 118%, respectively.

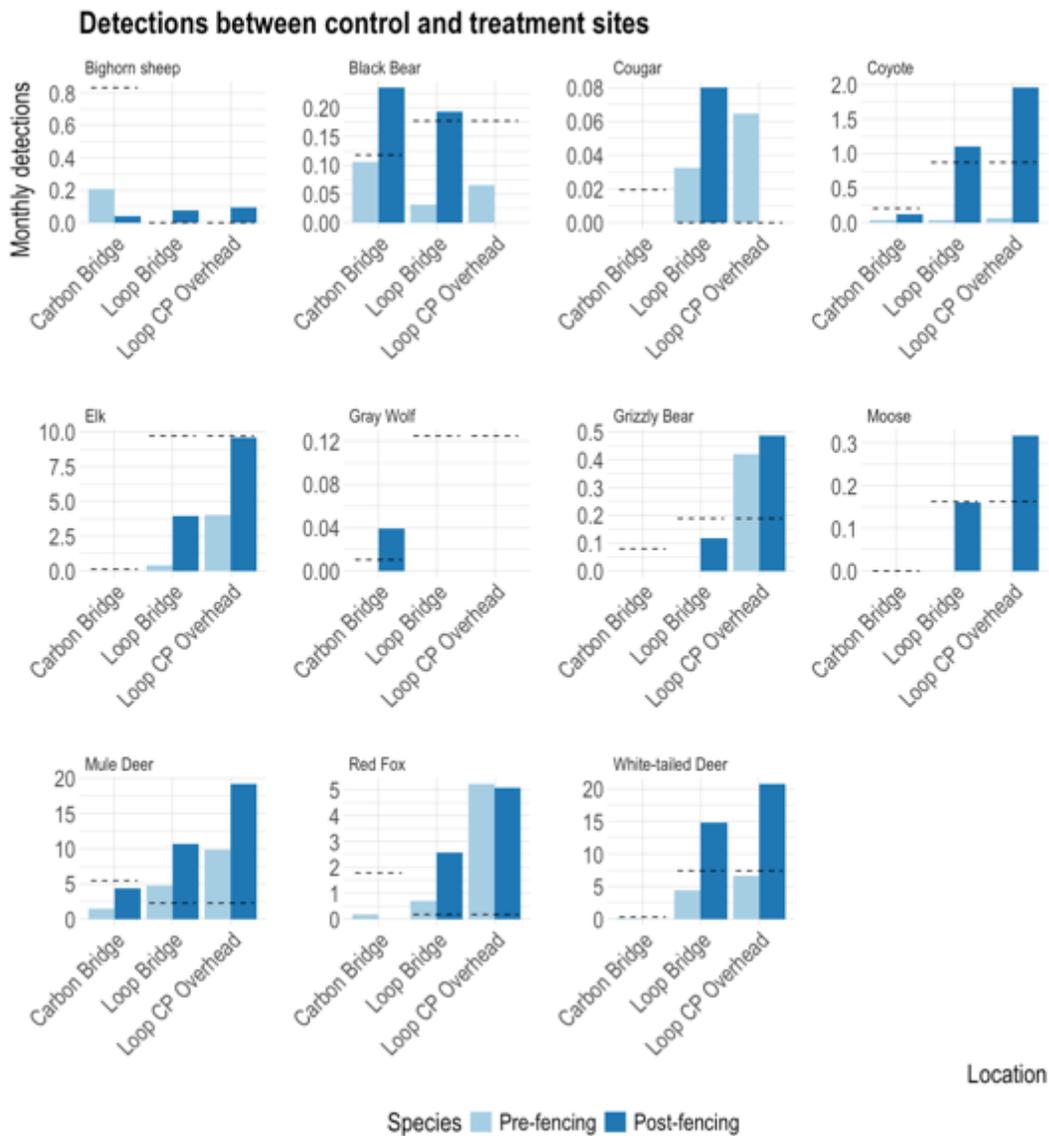
Figure 12: Comparison between control cameras and pre vs post fencing detection rates for common species at fenced sites. Average values for each location and species shown as dashed line.

Generally, most species increased their use of the structures following fencing, often exceeding detection rates found at control cameras (Figure 12). However, with only two years of data post fencing and some animals having low detection rates (0-3 detections per month) we are just starting to get a sense of how fencing is changing the use of these structures. Future years of monitoring on these sites and assessment of future phases will provide more robust insights.

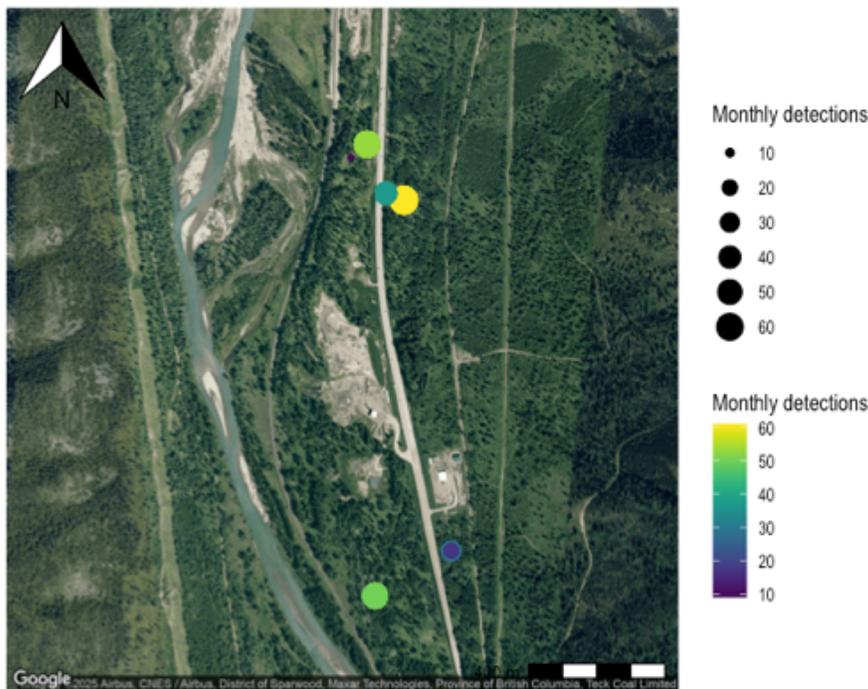
### Sparwood West Location Refinement

*Figure 16: Average monthly detection rates for proposed north and south Sparwood West underpass sites. The north site is preferred from an engineering perspective, and appears to have higher wildlife detection too. Future land use on the east side of the highway needs to be considered.*

In Phase 5 we intend to install a wildlife underpass west of Sparwood, before Olsen Crossing (Figure 1). Two possible locations for the underpass have been identified. We installed wildlife cameras adjacent to these possible locations to assess wildlife use at these sites (Figure 16). The northern location is preferable from an engineering perspective but we wanted to compare wildlife use of each site. Wildlife detection rates from the cameras suggested the northern site is also preferable from a wildlife use perspective. Land tenure, specifically future development that could alter wildlife use remains a concern here and agreements with the City of Sparwood should be made before construction to reduce future impacts to wildlife connectivity around crossing structures.

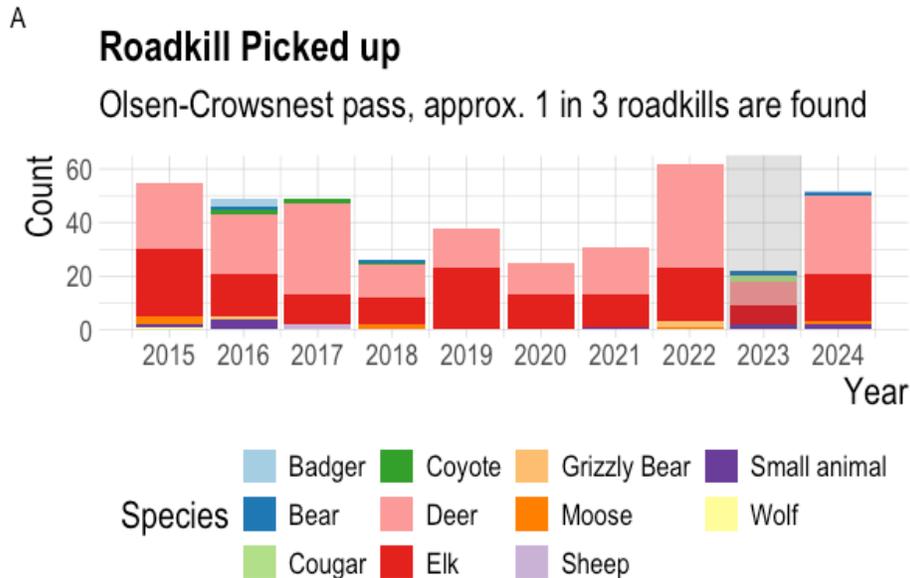
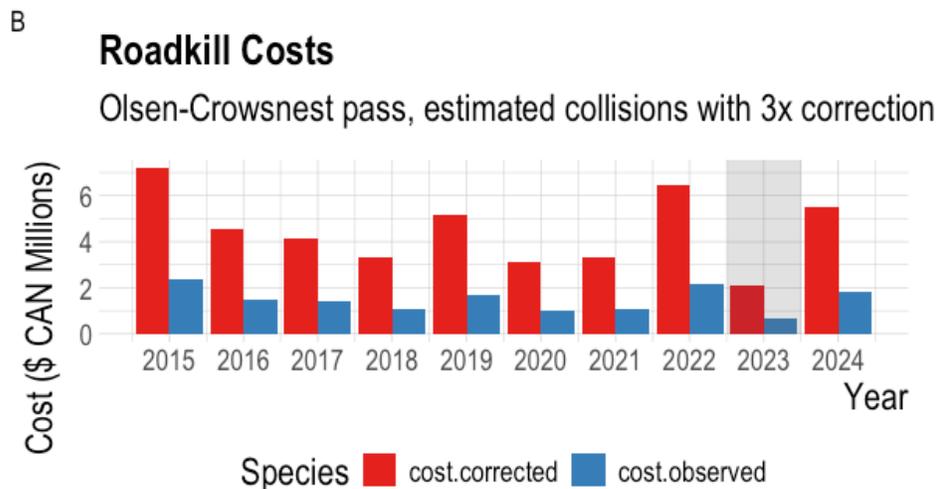
Figure 21: A) Number of roadkill detected along the project length per year. These counts are uncorrected for roadkill that are known to be missed in these data, and B) estimated cost of these collisions to society. Corrected costs account for unreported roadkill. Studies on collared elk, grizzly bear, and roadside surveys have indicated that only ~1 in 3 roadkill are reported. Grey shading shown over 2023 as data for this year are currently being checked for accuracy and cleaned by MOTT due to expected missing records.

We assessed the number of roadkill annually detected along the project length, which we then used in conjunction with Table 1 to estimate the cost of wildlife-vehicle collisions to society (Figure 21). On average, 41 roadkill are reported each year, and this may be as high as 123 after accounting for roadkill not detected. Wildlife-vehicle collisions in our study area are estimated to cost society at least an estimated \$1.5 million, but the cost could be as high as \$4.5 million after accounted for undetected roadkill. We confirmed that the RTR:BC focal area is a hotspot for wildlife-vehicle collisions (Figure 22). The RTR:BC project area has the highest rate of wildlife-vehicle collisions for a highway traversing the Rocky Mountains in Southeast BC (including Highways 43 and 93). We note that areas of high wildlife-vehicle collision intensity do occur outside the mountains in the Rocky Mountain Trench near Jaffray and could be the focus of future work.

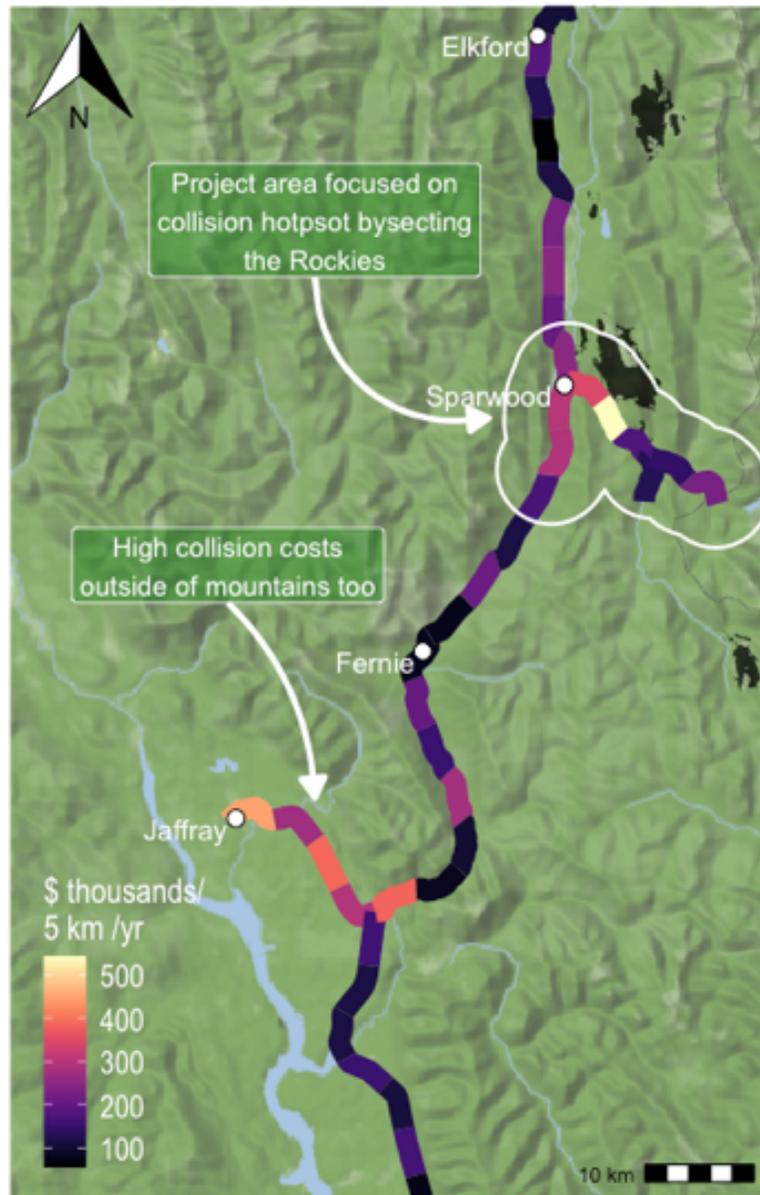
## Regional Roadkill Costs

*Figure 22: Estimated wildlife-vehicle collision costs along southeast BC Highway 3, 93, and 43. We estimate the annual wildlife-vehicle collision cost for each 5 km segment and note this is a minimum cost as it doesn't account for the many undetected roadkill that aren't found but likely still damaged a vehicle. The true cost could be ~3x higher per segment.*

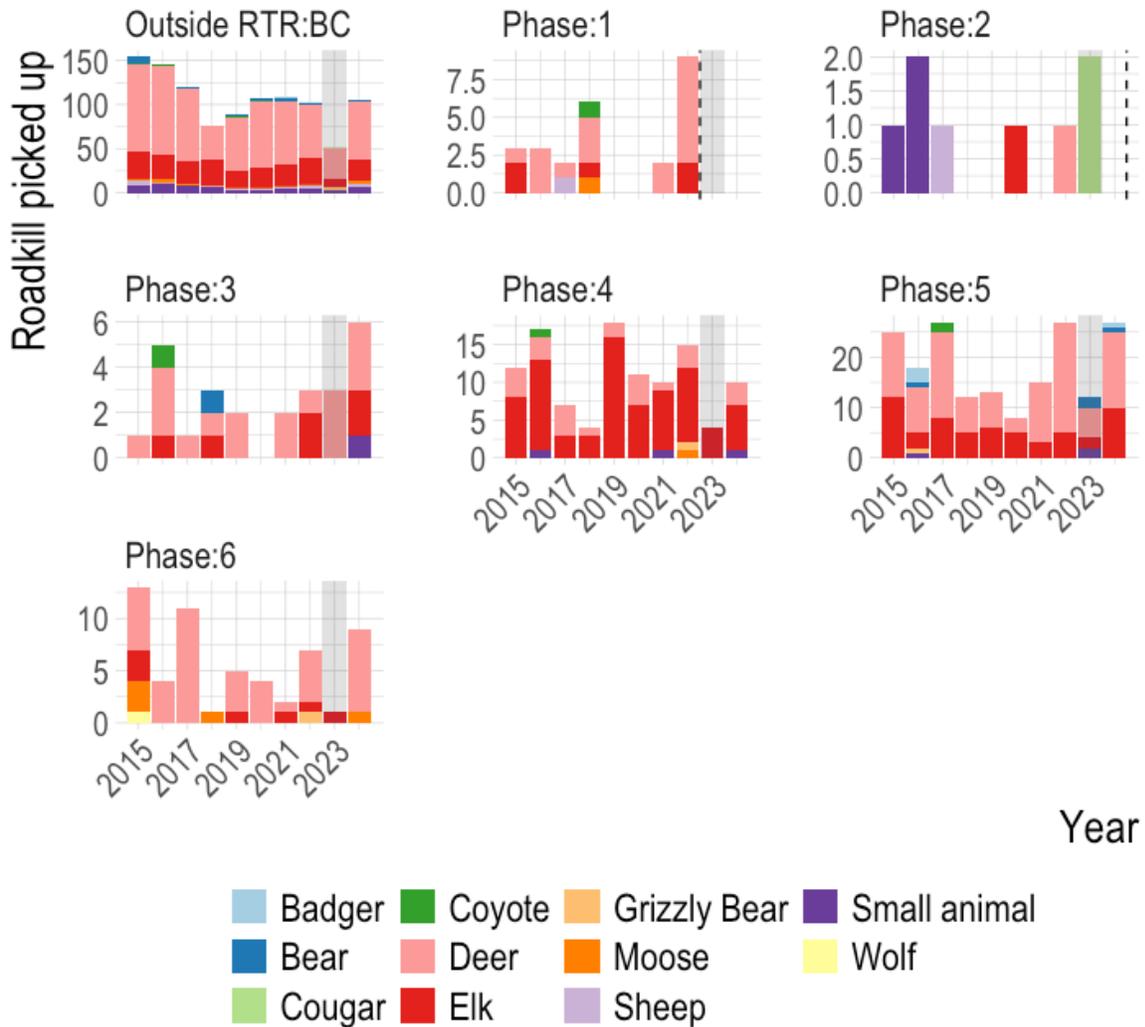
## Roadkill Along Highway 3 in SE BC

Figure 23: Number of roadkill picked up along Highway 3 between Jaffray and AB Border per year, broken up by RTR:BC phases. 2023 (greyed out) as MOTT is still working to remedy some data completeness here. Dashed line indicates when fencing was installed in each phase. Studies on collared elk, grizzly bear, and roadside surveys have indicated that only 1 in 3 roadkill are reported.

We assessed the influence of fencing along Phase 1 in reducing wildlife collisions (Figure 23). Phase 2 fencing was completed in Nov 2024 so it's currently too early to assess collision reductions in this section. Based on the data we had access to, the rate of collisions appears to have dropped in the Phase 1 section compared to the pre-fencing period (2015-2022). A few caveats are required for the Phase 1 interpretation, including 1) the "after" period is primarily based solely off 2024 data, as 2023 has data quality issues which are actively being worked on by MOTT, and 2) some animals have been hit inside the Phase 1 section post fencing that either were picked up by someone other than the highway contractor and thus not showing up here. In the case of someone else picking them up, we assume the rate of this is static before and after fencing so should not bias the before-after comparison. In addition, if anything we'd expect possibly higher retrieval rates after fencing by the highways contractor simply due to some animals that were previously struck and escaped the right of way before fencing would not be reported whereas now they presumably would be stuck inside the fence if they did breach the fence and get hit. The degree of roadkill reduction from completed project phases will become more robust as additional phases are completed, more post-fencing years accumulate, and the roadkill data error checking is completed by MOTT.
